Cattaraugus County BoE/Museum Exterior Photos

Cattaraugus County Museum Inside Photos

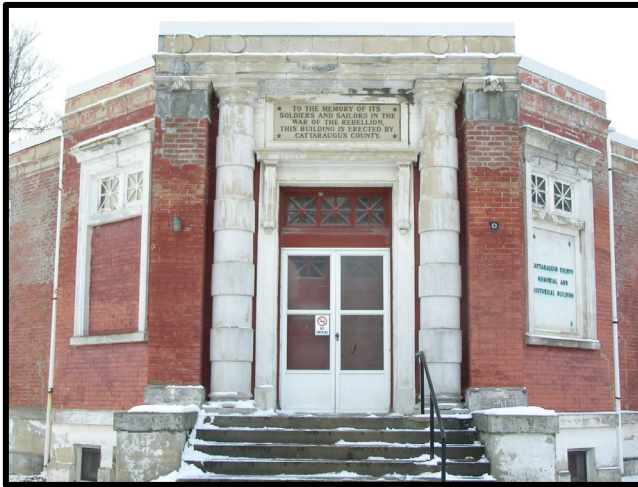
Front of the Museum.

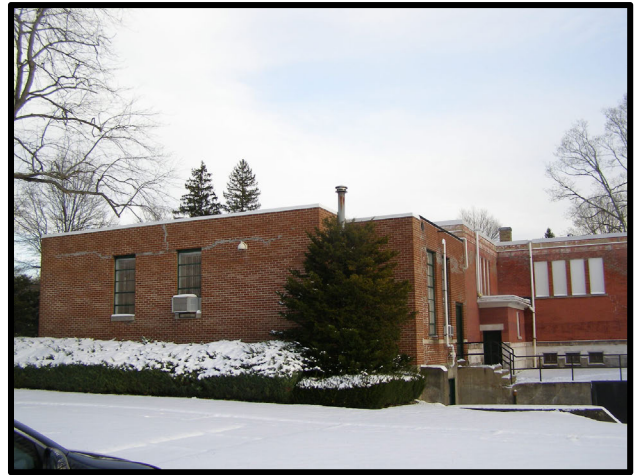
Right side of the Board of Elections.

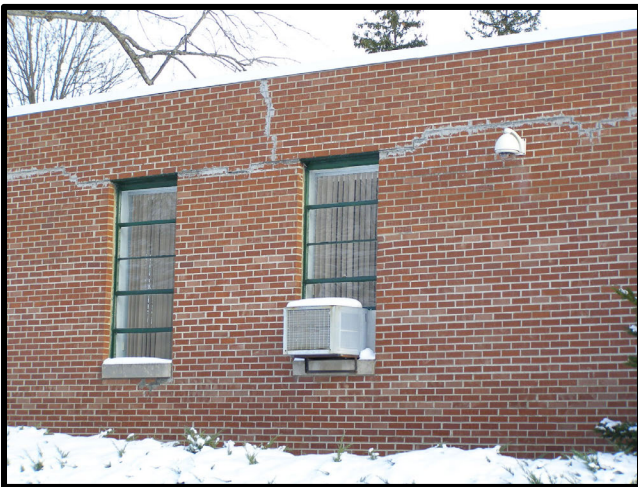
Large crack on the right side of the Board of Elections.

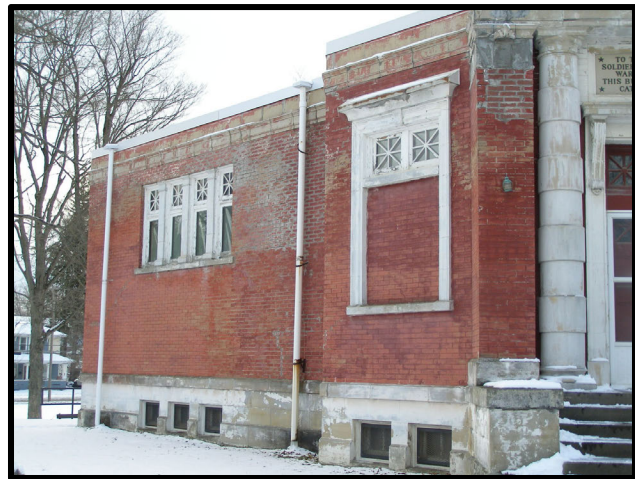
Left side of Museum.

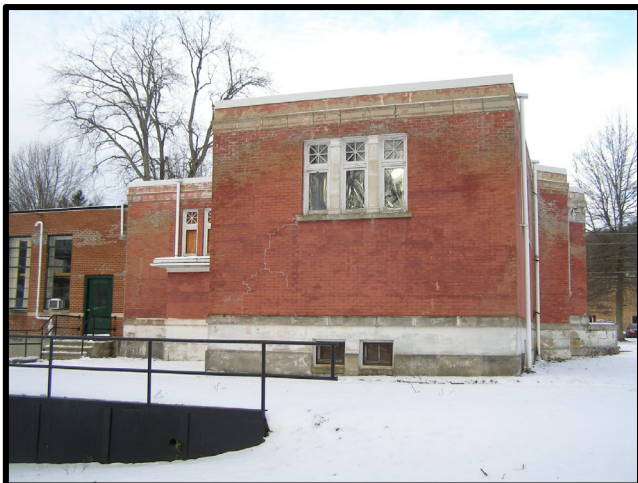
Back side of the joined buildings:
Board of Elections (left) and Museum (right).

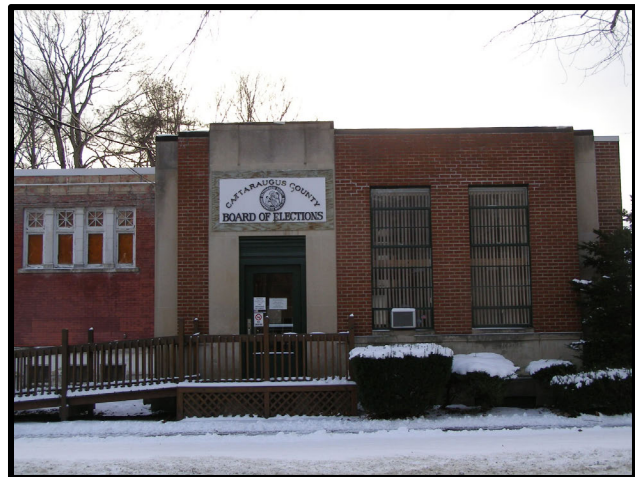
Front entrance to the Board of Elections.
(an addition to the right side of the Museum)

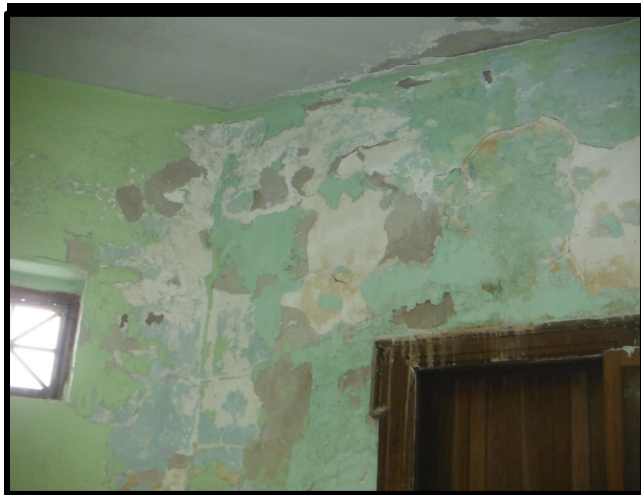
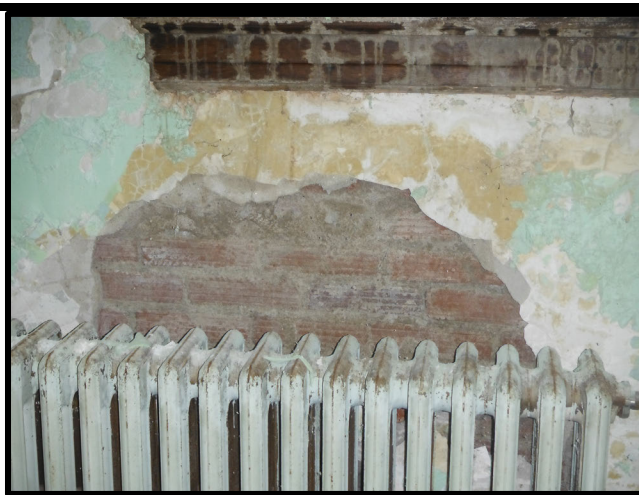
Water infiltration seeping through walls due to the breakdown of brick pointing, and poor roof conditions. This not only caused internal damage but mold as well.

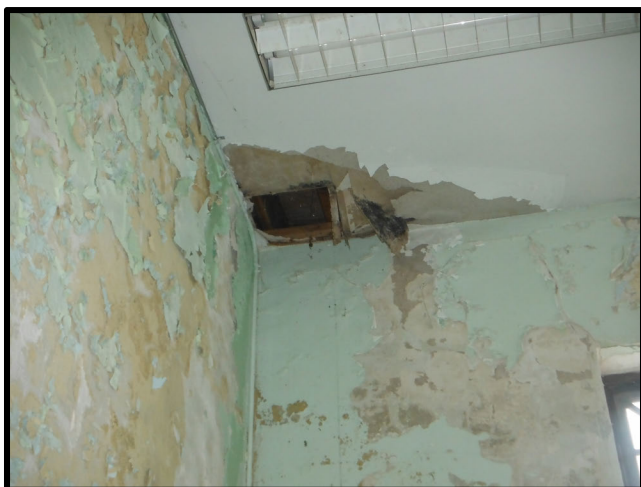
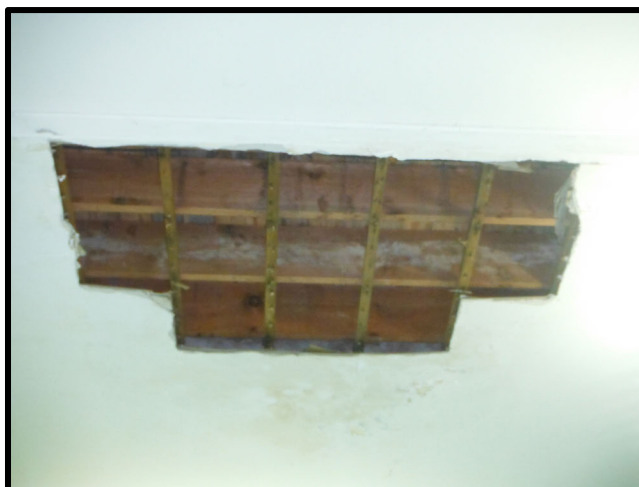
Internal ceiling damage from poor roof conditions (pitch and tar roof).

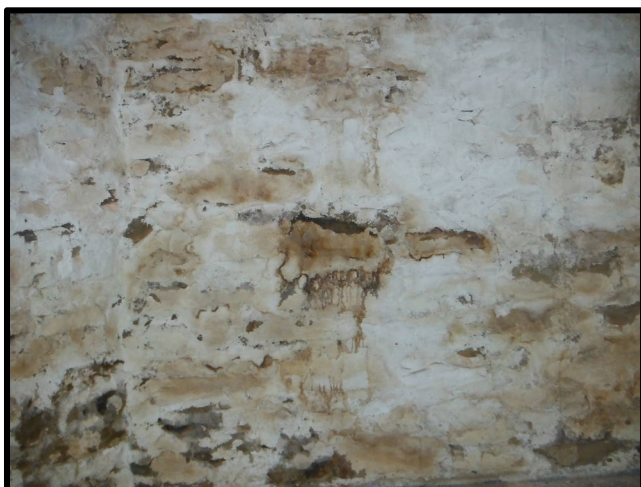
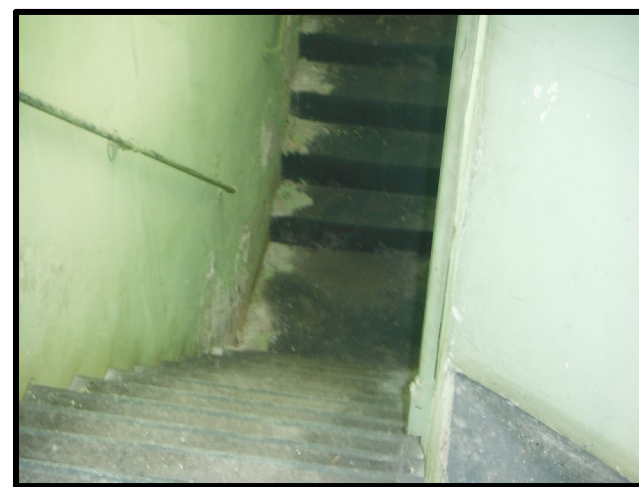
Field bricks allow water to seep into foundation which weakens structure and causes mold. Stairwell too steep and does not meet current codes or ADA compliance standards.

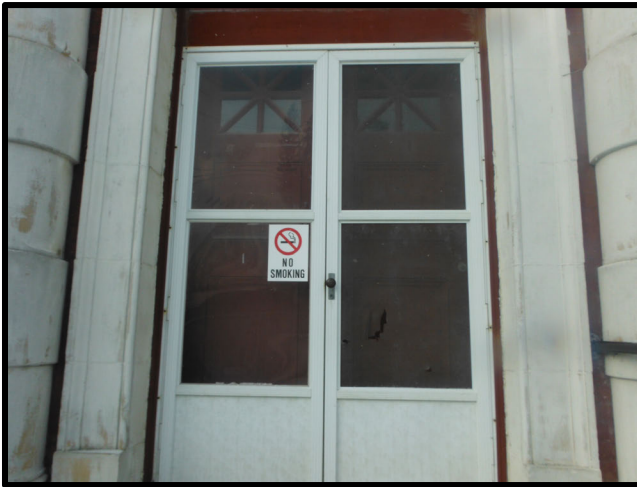
Front doors are too narrow to meet Americans with Disabilities Act standards.

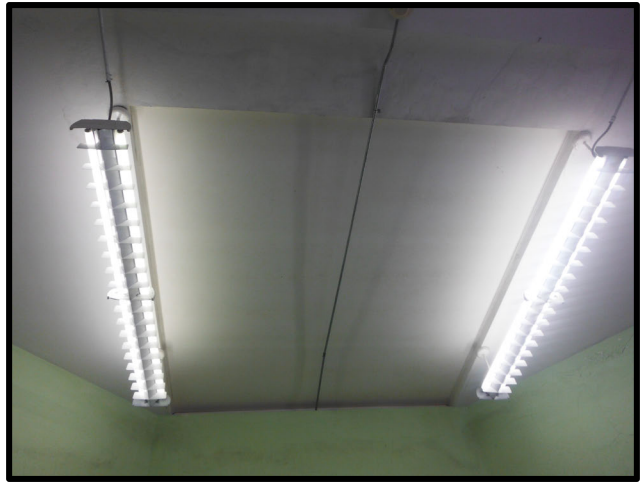
Original dome was removed after water leaked into the building and caused major damage.

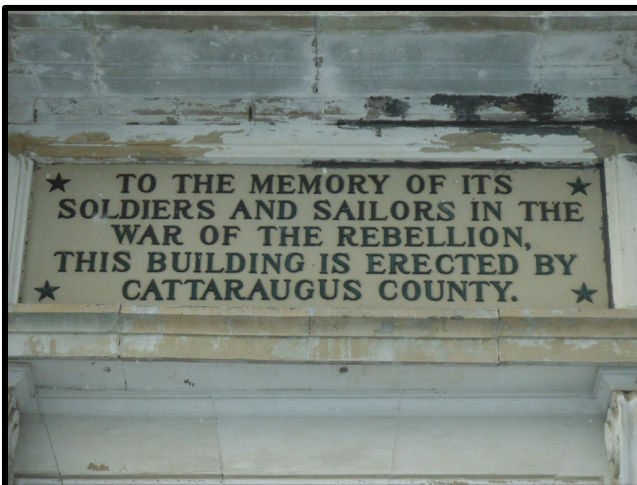
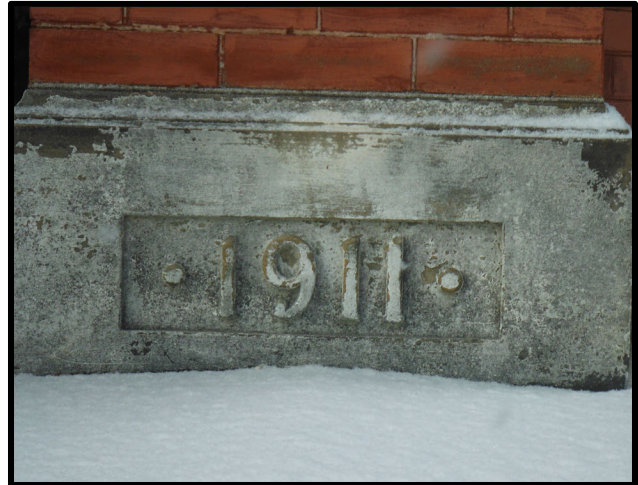
Key elements of the building: Dedication Plaque and Cornerstone will be saved.

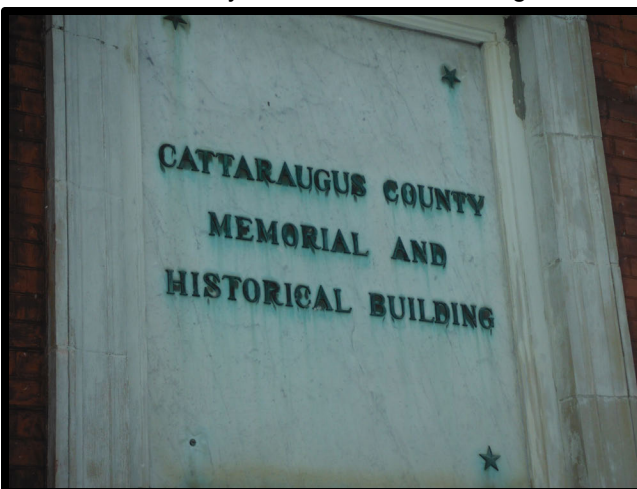
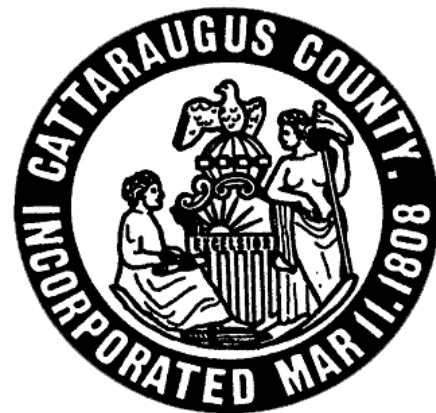
Another key element of the building: Marble plaque naming the building.
